(Final Report, Revised July 11, 2017)  
Condition Assessment  
&  
Reserve Fund Plan Update  
2017  
**SNOW HILL**  
Warrenton, Virginia

RE: **CONDITION ASSESSMENT AND RESERVE FUND PLAN UPDATE 2017**  
**Snow Hill Homeowners Association**  
**(Final Report, Revised July 11, 2017)**  
Warrenton, Virginia  
Project No. 8403

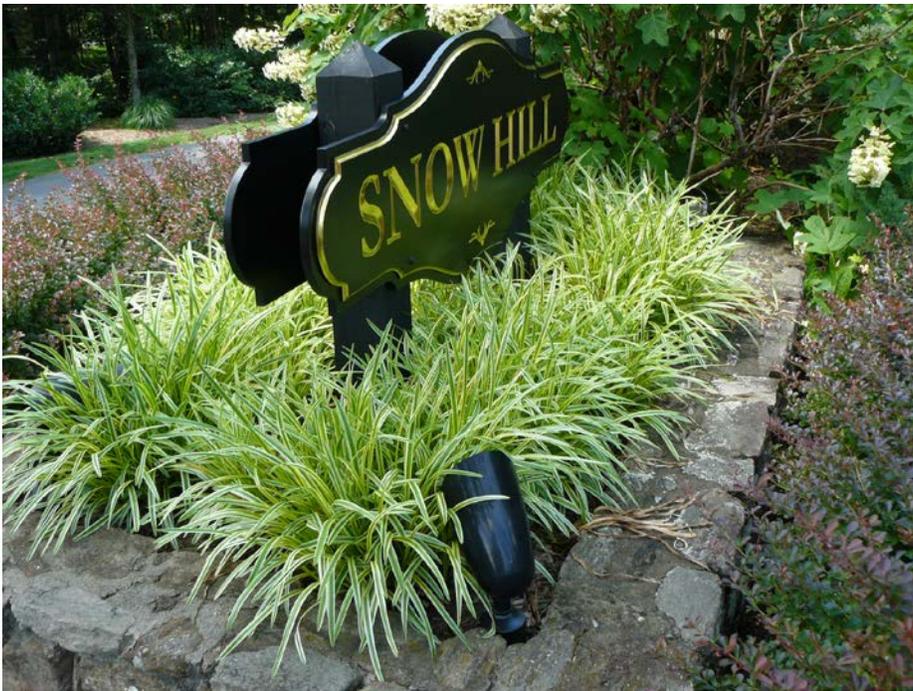
**PHOTO #1**  
The main entrance sign, stone planter, and the landscape lights appear to be in continuing good condition.

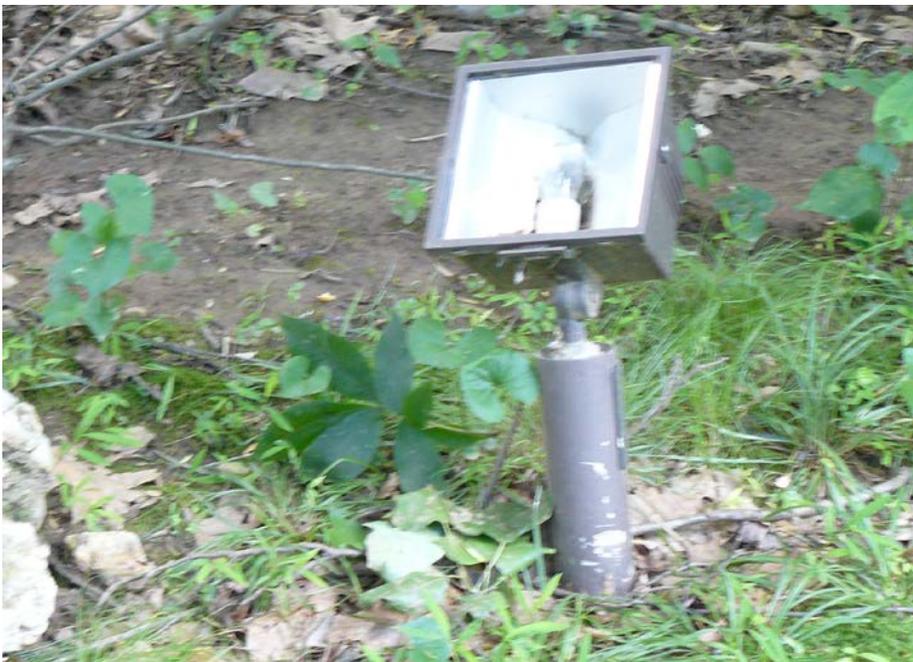
1.3	Main Entrance Landscape Lighting	6	EA	\$550.00	\$3,300	20	2018	100%	\$3,383	2028	100%	\$4,330	2038	100%	\$5,543	Six lighting fixtures are installed adjacent to the entrance on both sides of the road. They appear to be high-quality fixtures, and they appear to be in continuing good condition. There are five of one type of fixture and one of another type. Lighting was not observed after dark, but no problems with lighting were reported by Management. The Board requested the timing for this component.

**PHOTO #2**  
The landscape lighting installed along Snow Hill Drive at the entrance appear to be in fair to continuing good condition. Lighting was not observed after dark.

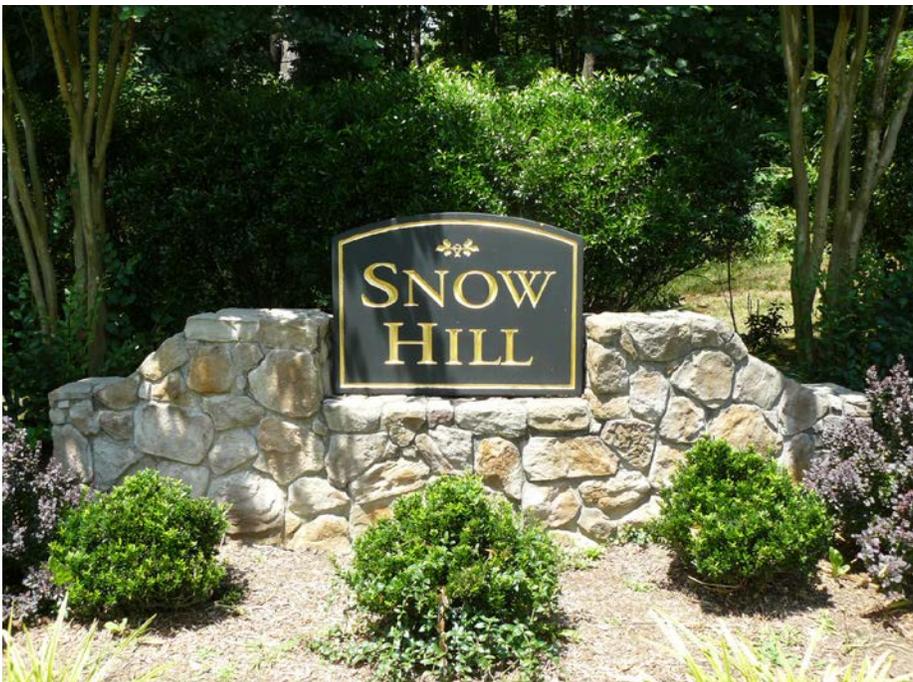
1.7	Rear Entrance Landscape Lights	2	EA	\$800.00	\$1,600	10	2022	100%	\$1,810	2032	100%	\$2,317	2042	100%	\$2,966	Two ground mounted L.E.D. landscape lights are installed at the rear monument. The right side light appears to be deflected, but its operational status was not observed. We are budgeting for replacement of both lights near-term. The Board requested the timing for this component.

**PHOTO #3**  
The rear entrance sign and monument appears to be in continuing good condition. One landscape light at this monument is deflected.

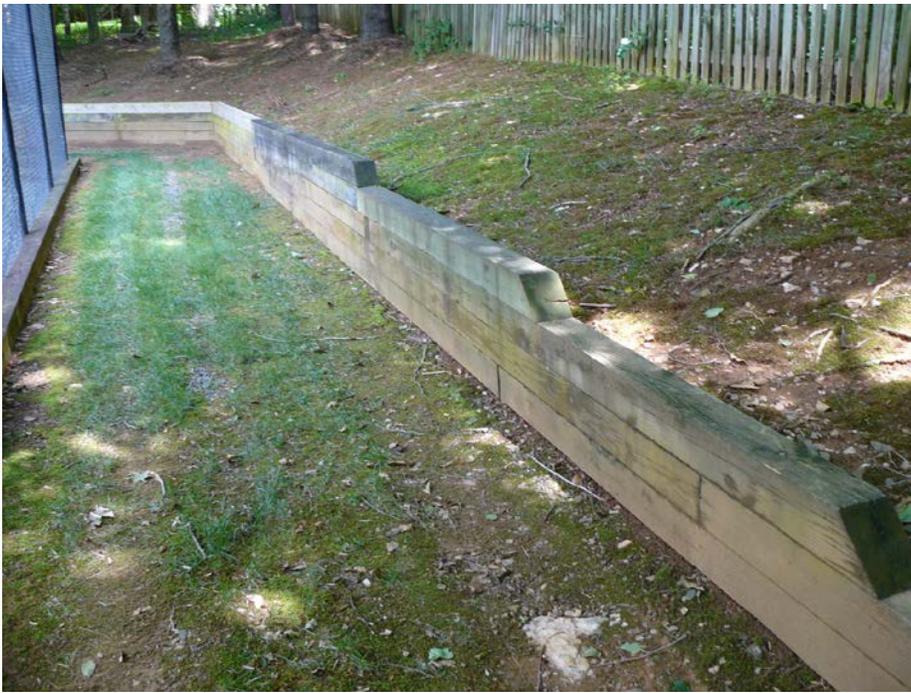
1.8	Wood Retaining Walls	784	SF	\$32.00	\$25,088	20	2019	100%	\$26,358	2039	100%	\$43,191				This category includes the wood retaining walls constructed at the grade differential at the rear of the tennis court area, at the rear boundary of each tennis court, and the wood planters constructed at the front of each tennis court. The walls appear to be in fair condition with minor deterioration, but no deflection observed.

1.9	Wood Riser & Border Timber Steps	380	LF	\$13.00	\$4,940	20	2019	100%	\$5,190	2039	100%	\$8,505				This category includes the pressure-treated wood timbers making up the borders and risers of the steps that provide access to the tennis courts and the wood border along the side of the tennis courts. These appear to be in generally fair condition having had some timbers replaced in recent years. This type of step and riser construction is generally problematic because of settlement of the pedestrian surface material. Diligent maintenance of the gravel treads to prevent tripping hazards is essential throughout the life of the steps. Additional gravel should be installed to bring the surface flush with the riser timbers.

**PHOTO #4**  
The wood retaining walls and the timber steps range from fair to continuing good condition.

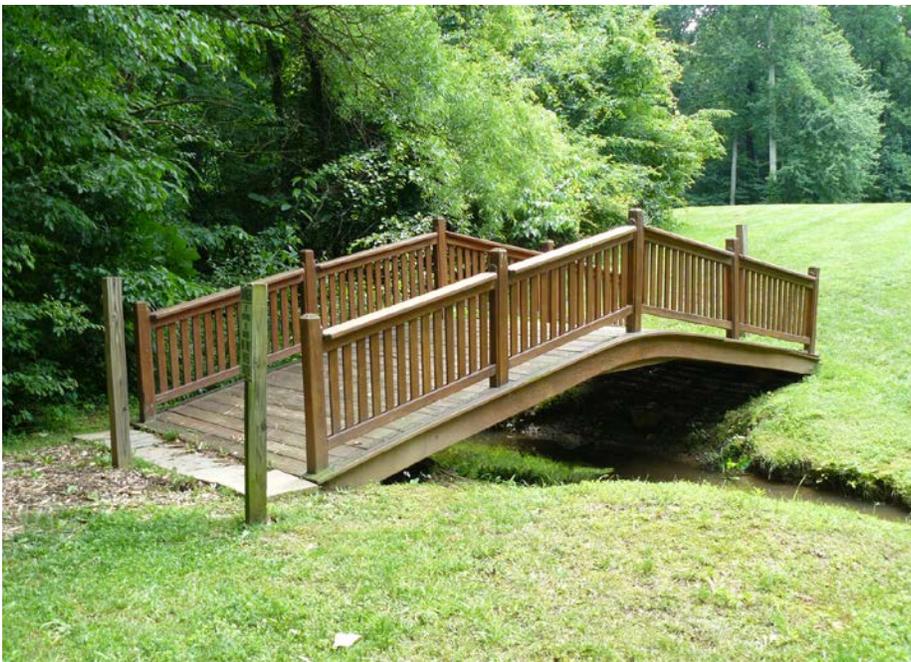
1.10	Wood Footbridge	1	LS	\$4,000.00	\$4,000	15	2020	100%	\$4,308	2040	100%	\$7,058				The footbridge appears to be in fair condition with no major deterioration except minor rot of the horizontal treads was observed. The cost for the replacement bridge used in the study is based upon the actual construction cost plus inflation.

**PHOTO #5**  
The wood footbridge is in fair condition. A few of the treads are beginning to deteriorate, but the railing and bridge framing appear to be in continuing good condition.

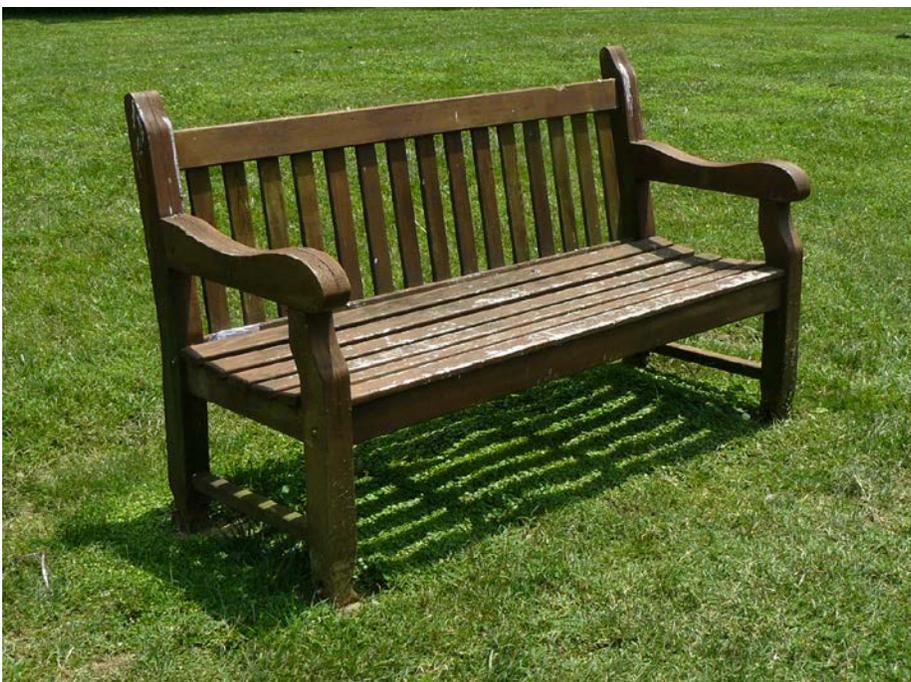
1.12	Outdoor Furniture	1	LS	\$3,500.00	\$3,500	15	2020	100%	\$3,769	2035	100%	\$5,459	2050	100%	\$7,906	This category includes two wood benches located at the retention ponds and the wood trash enclosure located at the tennis court area. They appear to be in generally fair condition with damaged, deteriorated components. They are scheduled for near-term replacement. The furniture may be cleaned and re-stained, which may provide a longer service life.

**PHOTO #6**  
The outdoor furniture is in generally fair condition. Cleaning and re-staining the furniture may help to extend the service life and improve appearance.

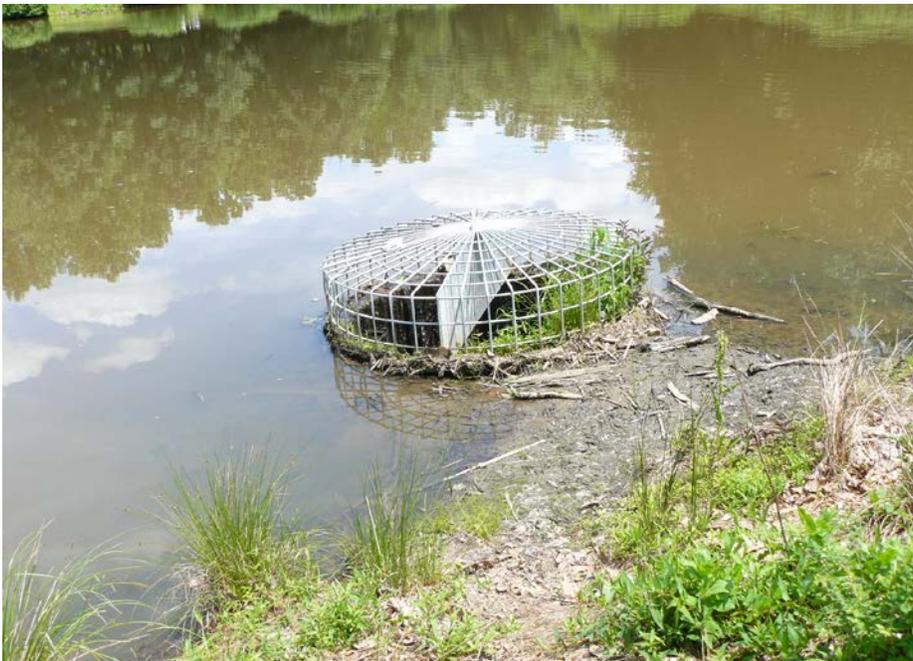
**PHOTO #7**  
The upper pond overflow riser has vegetation growing in it, which should be cleared before it becomes an issue.

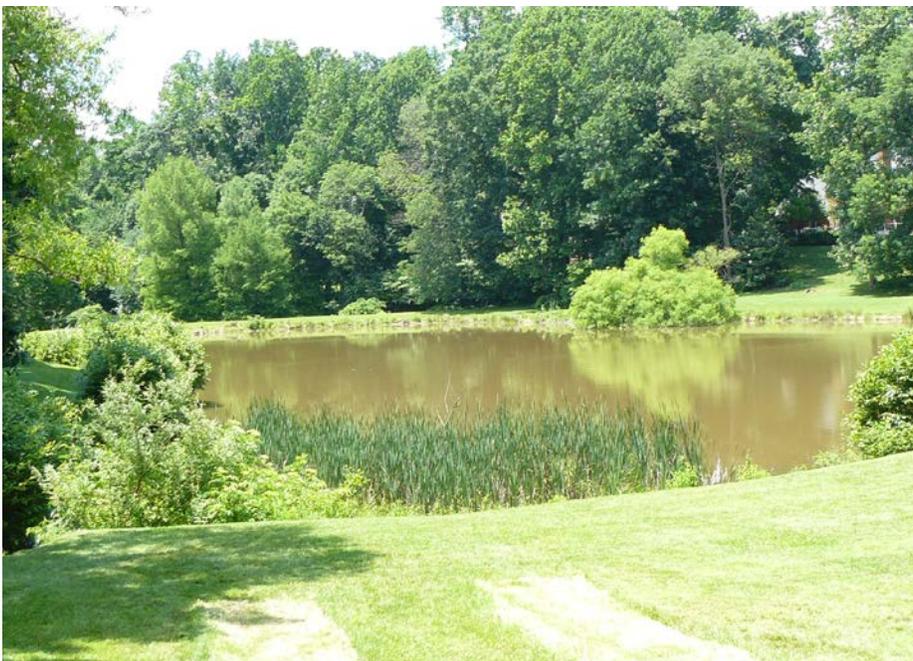
**PHOTO #8**  
The upper pond appears to be healthy. Heavy rains the night before had helped the pond reach a full level.

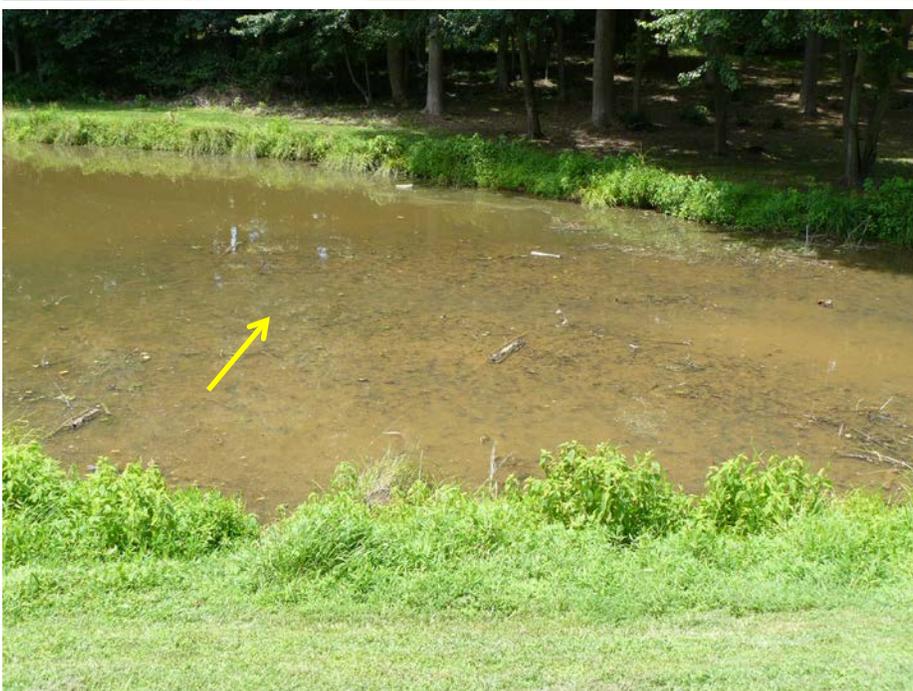
1.13	Retention Pond & Riparian Restoration Allowance	1	LS	\$20,000.00	\$20,000	5	2017	100%	\$20,000	2022	100%	\$22,628	2027	100%	\$25,602	The two ponds appear to be the result of excavation and construction of earthen impoundment structures. The upper pond overflow riser was observed with some vegetation, which should be cleared. The lower pond overflow structure appears to be in continuing good condition. There are a number of pond maintenance issues such as shoreline stabilization, chemical applications for weed control, bacterial improvement to control algae, surface aerators, diffusers, beaver control, mosquito control, and installation of sedimentation forebays, all of which may be required at some time over the life of a pond. We understand that Solitude Lake Management is maintaining the ponds under contract. This component should cover issues that the maintenance company does not. This allowance is not intended to cover the cost of dredging, if determined to be required.

**PHOTO #9**  
The inlet of the lower pond was quite full of sedimentation. The ponds may require dredging at least every 15 to 20 years.

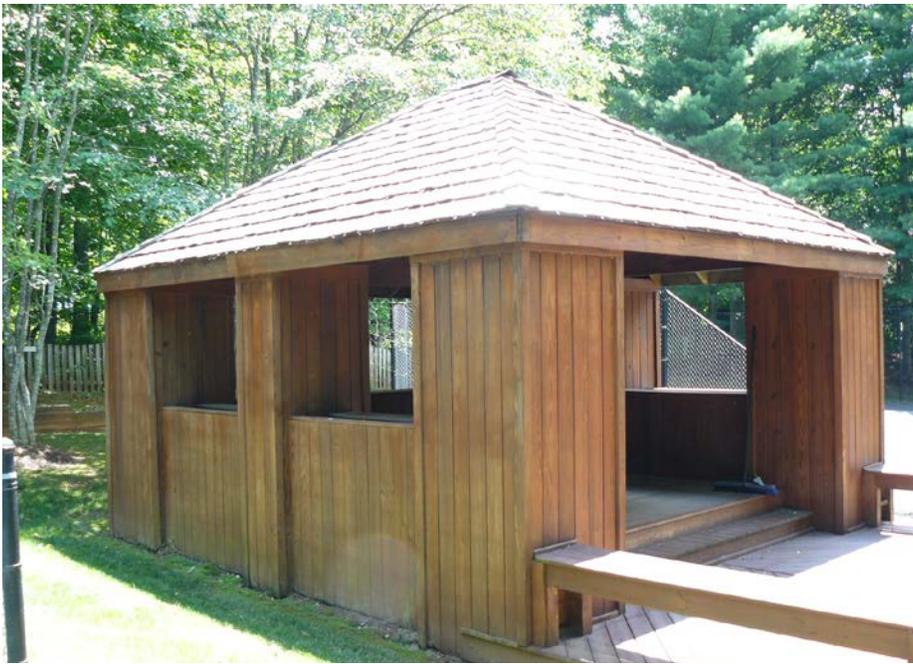
2.1	Tennis Pavilion	1	LS	\$18,600.00	\$18,600	35	2022	100%	\$21,044	2057	100%	\$49,942				The tennis pavilion is constructed of wood timbers covered with pressure-treated lumber. The floor is constructed of pressure-treated lumber. Built-in planters are constructed at window openings. All interior components appear to be in continuing good condition for their age with no deteriorated or damaged areas observed. The exterior lumber and trim appears to be weathered with beginning deterioration observed. The remaining projected service life is dependent on preventative maintenance being performed.

2.2	Pavilion Re-Roofing	350	SF	\$8.00	\$2,800	20	2042	100%	\$5,191							The roof of the pavilion is a 4/12 pitch, wood shake construction. The roof appears to be in fair condition with a couple of curled shakes observed. These deficiencies were noted in 1999 and 2004, and appear to have not resulted in any leaks as evidenced by a lack of water staining on the underside of the plywood sheathing. Damaged or deteriorated shakes should periodically be replaced.

**PHOTO #10**  
The Tennis pavilion structure, roofing, and siding ranges from fair to continuing good condition. Continued maintenance of the building will be required in order to achieve a long service life.

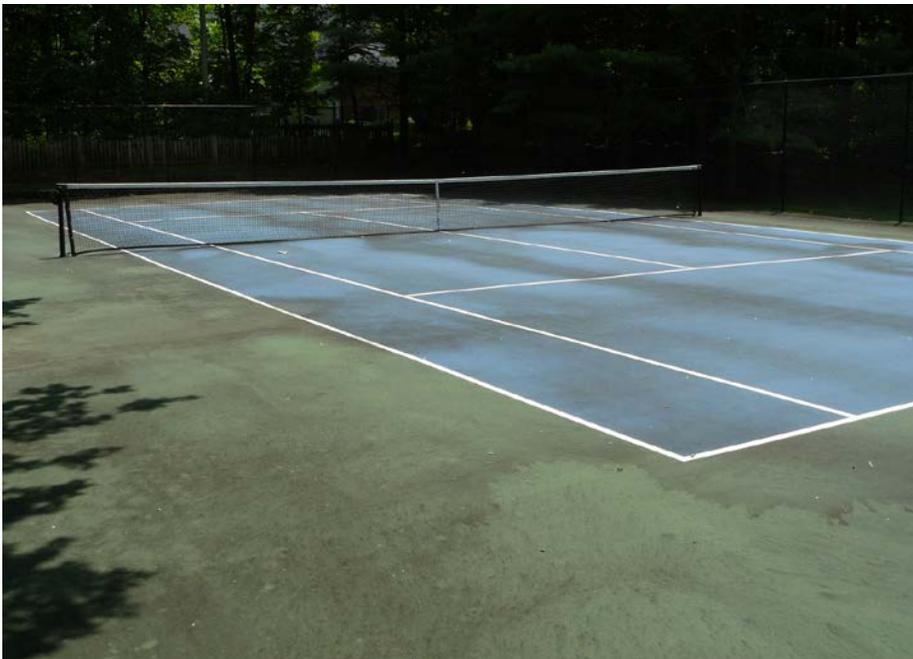
2.4	Tennis Court Restoration Project	2	EA	\$21,000.00	\$42,000	20	2031	100%	\$59,345	2051	100%	\$97,244				The tennis courts were restored circa 2011 and are in generally good condition. No cracking of the courts were observed. However, the color coating is in poor condition, requiring replacement near-term (Component 2.5). We have scheduled restoration of both courts mid-term in the study. With proper maintenance, tennis court surfaces should achieve a long service life. Homeowners should be advised that tension on the nets should be released when not in use, and nets should not be over-tensioned when in use, which can cause cracking at the net post footings, thereby allowing water infiltration into the court. Any cracks which occur in the future should be sealed to prevent water infiltration. There are several after-market rubber/composite products offered for court restoration as an alternative to standard restoration practices. In our experience, in the case of court cracking, these methods should not be employed as they are generally unsuccessful at mitigating dynamic cracks except for a very short period of time.

**PHOTO #11**  
The tennis courts were restored circa 2011. Structurally, the courts appear to be in good condition, with no cracking observed. However, they require new color coating near-term.

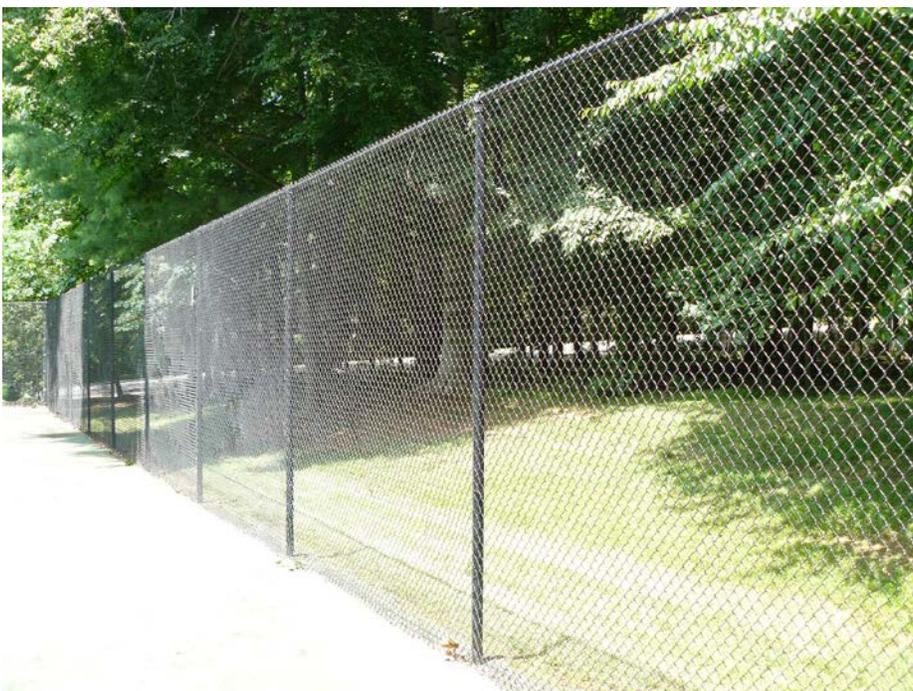
**PHOTO #12**  
The tennis court fencing is in continuing good condition.
